DW1000 Errata

Version 1.1

This errata document details known issues with the DW1000 product. Where available workarounds are presented.

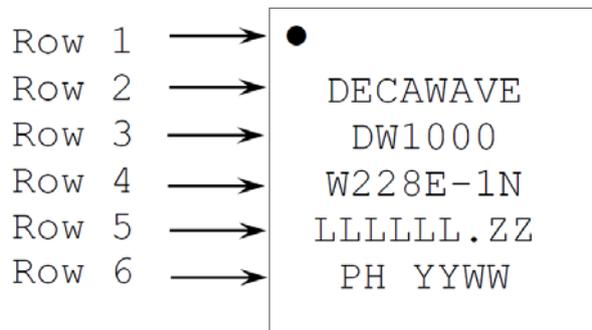
Figure 1 Device Package Markings

Row 1: Pin 1 Designator	Used for device orientation
Row 2: Company Name	DECAWAVE
Row 3: Part name	DW1000
Row 4: DW1000 part number	W228E*-1N

* DW1000 silicon revision identifier. In this example the revision of the IC is "E". **Devices marked with silicon revision identifier prior to 'E' (for example 'C') should not be used for DW1000 designs.**

Row 5: Manufacturer lot number	LLLLLL.ZZ LLLLLL is root wafer fab lot number. ZZ is the lot split number from fab.
Row 6: Package assembly information.	PH : Manufacturing Site Code YYWW : Date Code (YY =Year; WW = Week)
